FURTHER STUDY OF RESTORED AND UN-RESTORED TEETH SUBJECTED TO HIGH TEMPERATURES

G. Merlati,¹ C. Savio,¹ P. Danesino,² G. Fassina,² P. Menghini¹

ABSTRACT

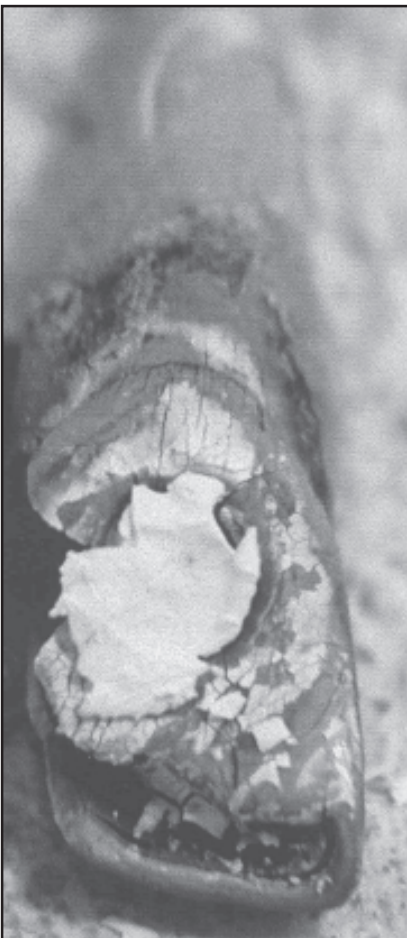
Fig.5: Class I composite filling after exposure to heat up to 600 °C

600°C: macroscopically the samples were greyish, the crowns were disintegrated and the enamel fragments were detached. There were deep cracks in the roots but the fillings were in place and maintaining their shape. The composites were chalky white (Fig. 5). After handling, the crowns disintegrated completely but the fillings remained intact, maintaining both shape and dimensions.

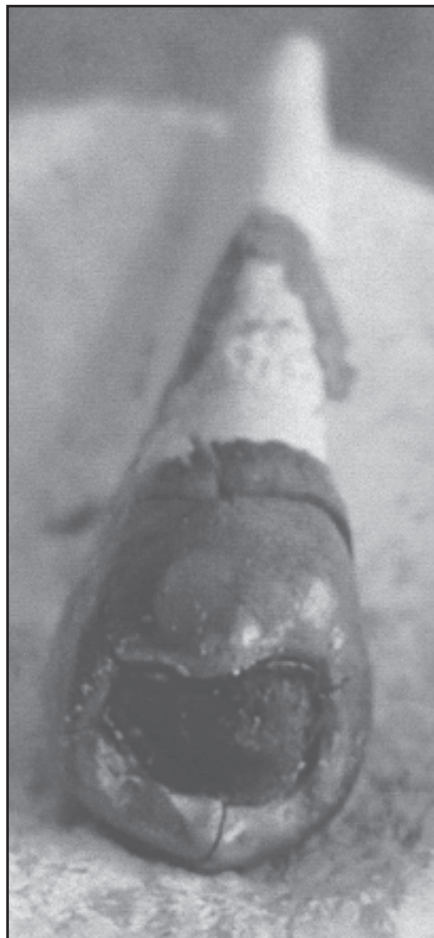
Fig.6: Class I amalgam filling after exposure up to 800 °C

800°C: the colour of the roots surfaces was chalky white, the crowns were greyish and there was cracking and separation between enamel and dentine as well as between dentine and fillings, while the roots remained whole. In the samples in which the crowns were intact, we observed a large fissure between dental tissues and fillings (Fig.6), while, in the samples in which the crowns were broken off, the fillings remained whole and maintained their shape. The composite fillings displayed a chalky white colour (Fig.7) with the inside surface of the fragments being blue-grey.
