# OBSERVATIONS ON DENTAL PROSTHESES AND RESTORATIONS SUBJECTED TO HIGH TEMPERATURES: EXPERIMENTAL STUDIES TO AID IDENTIFICATION PROCESSES

## ABSTRACT

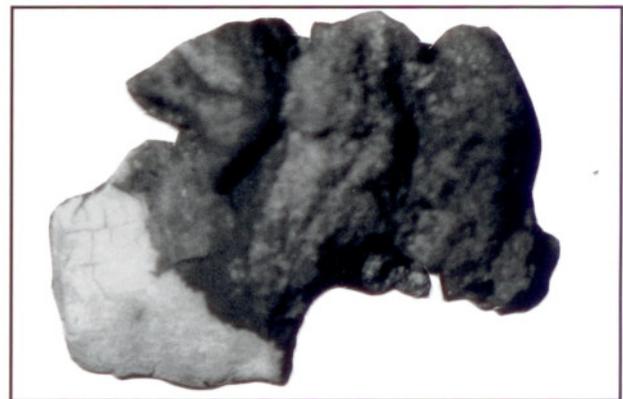
**Fig.2:** Stereomicroscopic image (20X) of a class I amalgam restoration recovered at a distance from the residual dental fragments after exposure to 800°C. The amalgam is in a partially melted state, altered in shape and structure and with a piece of dental tissue attached

**800°C:** the coronal part of the teeth had shattered and the amalgam fillings were recovered at some distance from the teeth in a partially melted state, altered in both shape and structure (Fig.2). The parts of the cavity that had contained the filling could be identified in the largest fragments of the crown and, particularly by stereomicroscope (20X), signs of the milling instrument were evident.

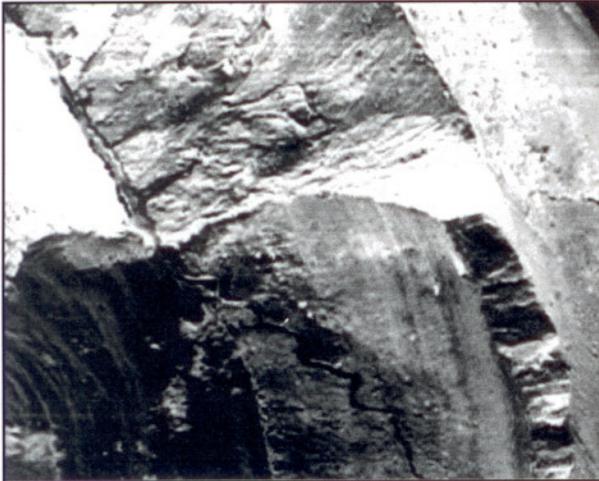
**Fig.3:** SEM image (510X) of a cavity prepared for repair with composite after exposure to 400°C. The marks caused by the bur during cavity preparation are visible

**400°C:** the composite restoration had detached and, although remaining whole, had undergone a change in colour to yellowish-brown; the same colour changes were seen in the compomer fillings but these had remained *in situ*. Stereomicroscopic (16x) and SEM (510x) examination of the cavity containing the composite fillings showed the surface markings caused during the preparation of the cavity (Fig.3).

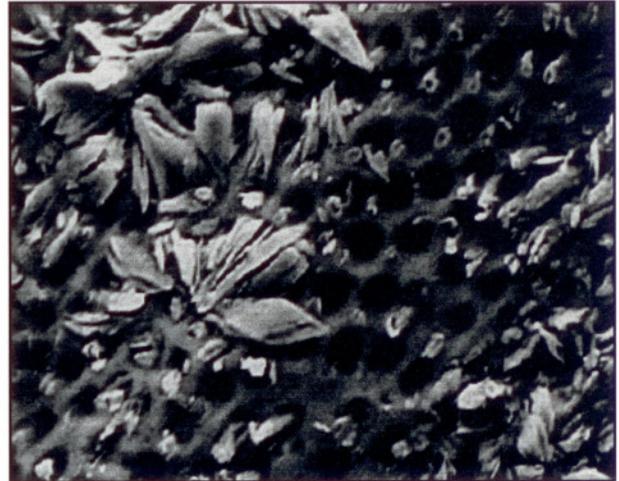
**Fig.4:** SEM image (1200X) the floor of a cavity prepared for the filling with composite material after exposure to 600°C. The dentinal tubules and a deposit of solid material, probably a residue of the incinerated composite, can be identified

**600°C:** there was no trace of the composite or compomer restoration: the almost black dental tissue was crossed by deep fractures and it was possible to identify only part of the preparation of the cavity on the vestibular facets. Stereomicroscopy (32X), revealed the characteristic grooves of milling while SEM (1200X) of part of the dentine underlying the composite filling displayed dentinal tubules and a deposit of well-defined shape that was probably the charred remains of the restoration (Fig.4).

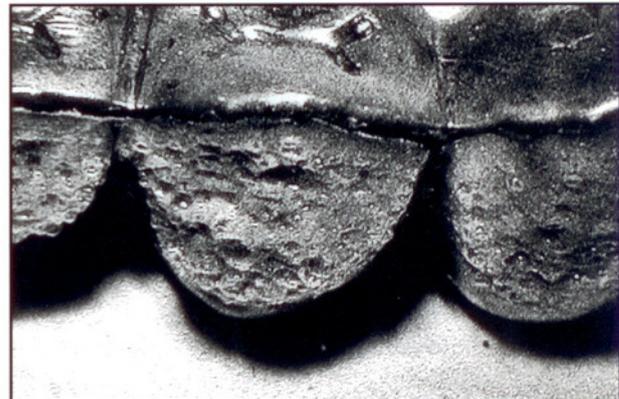
**Fig.6:** Stereomicroscopic image (20X) of a bridge covered with acrylic resin after exposure to 400°C. There is partial degradation and loss facing material. The alloy shows the first signs of oxidation with discolouration

**400°C:** macroscopic examination revealed partial degradation and loss of substance on the facets of the aesthetic material (acrylic resin based product or composite material). The alloy showed early signs of oxidation with discolouration (Fig.6).

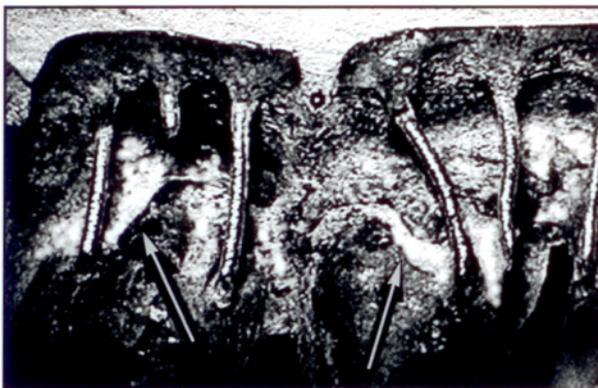
**Fig.7:** Stereomicroscopic image (8X) of a bridge covered with acrylic resin after exposure to 600°C. The loss of the facing can be seen while traces of the bonding system used at the alloy-facing material (silane) interface can be found on the surface of the alloy which has remained intact

**600°C:** the loss of the resinous component (acrylic based or composite material) could be appreciated macroscopically while traces of the bonding system used at the alloy-aesthetic material interface (silane) could be seen on the surface of the alloy (which remained intact) (Fig.7).
