A PILOT STUDY IN THE RECOVERY AND RECOGNITION OF NON-OSSEOINTEGRATED DENTAL IMPLANTS FOLLOWING CREMATION.

Running Title: Non-osseointegrated dental implants following cremation

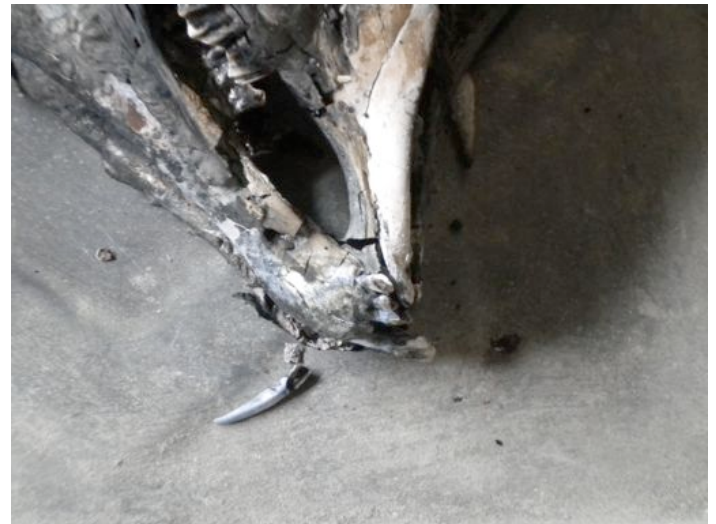
Fig.1. Partially incinerated sheep head showing dislodged tooth

During incineration teeth dislodged from their sockets in partially cremated sheep heads (Fig. 1) and following total incineration implants had fallen through the friable bone ash and had separated from the mandible (Fig. 2). All the implants appeared grey in colour (Fig. 3) and no distinctive gold-coloured crust was visible on the surfaces of the pure titanium implants.

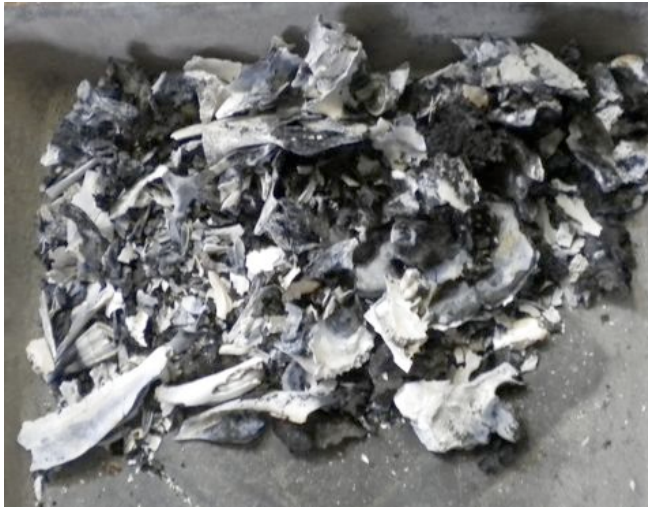
Fig.2. Ashened sheephead mass following incineration and removal from incinerator

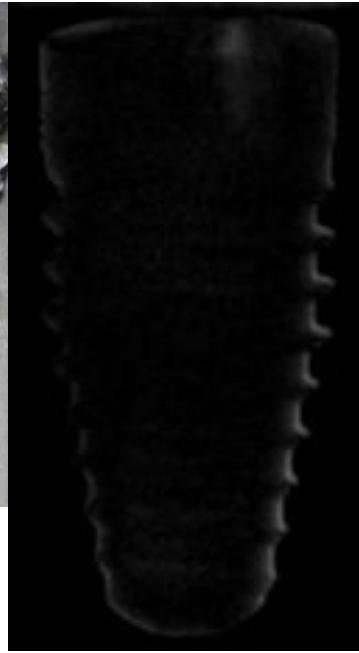
Fig.4. Image subtraction results for Nobel Biocare Replace Select™ 4.3 x 8mm, Similar results were observed for each brand of implant: minimal image difference after incineration.

The results of the comparative analysis in Adobe® Photoshop® CS revealed minimal image differences of all implants (Fig. 4). No detectable sagging was noted and the recognition features of threads and grooves were still identifiable.

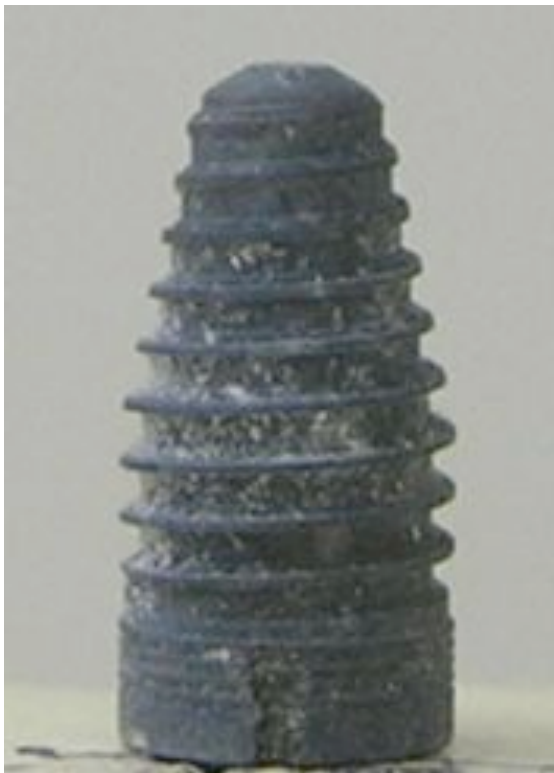
Fig.3. The Nobel Biocare Replace Select™ 4.3 x 8mm after incineration.

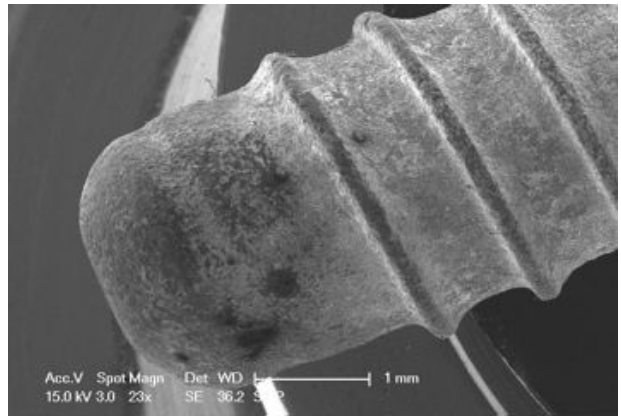
Fig.5. Base of the Straumann™ Regular 3.3 x 10mm showing little crust formation.

The SEM images of the implants indicated little crust formation on the surface as seen in Fig. 5. There were at least three distinct surface shade differences (black, grey and light grey) on the implants (Fig. 6). The elemental analysis revealed that the majority of the surface (light grey) consisted of titanium oxide (Fig. 7). Small black areas of carbon (Fig. 8) were identified and other areas contained bone elements (calcium and phosphorus) and serum salts (sodium, potassium, chlorine) (Fig. 9).

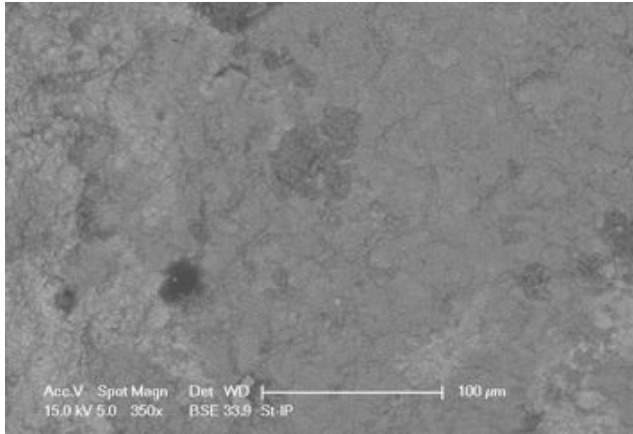
Fig.6. The three distinct surface shade differences (black, grey and light grey) on the implants.

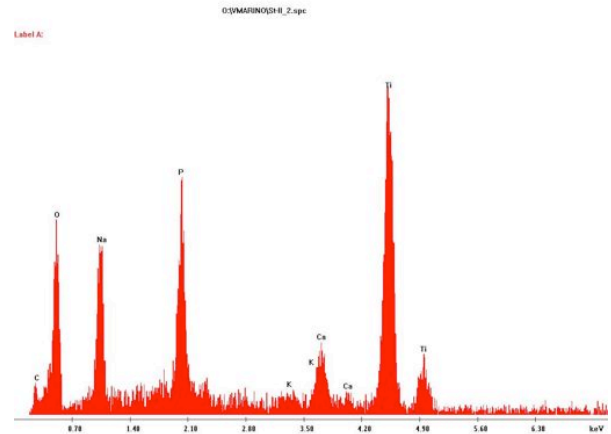
Fig.9. Elemental analysis of the grey area depicting bone elements and serum salts together with titanium.

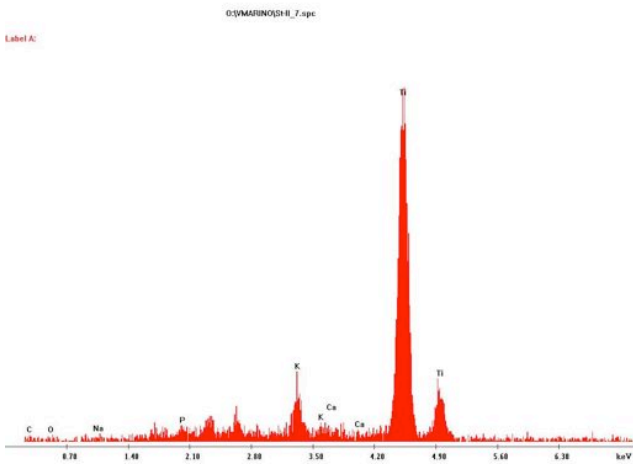
Fig.7. Elemental analysis of the light grey area depicting a peak of titanium.

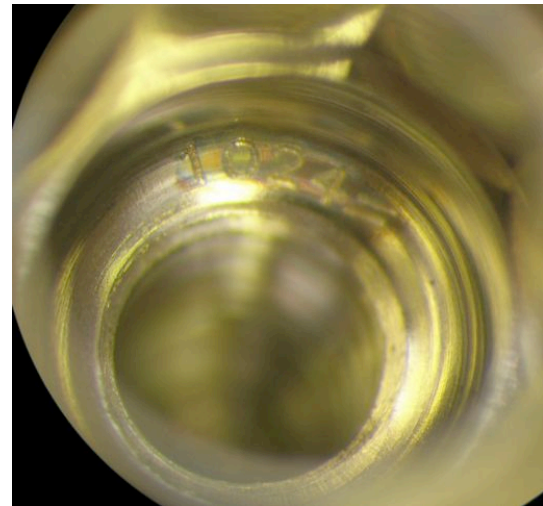
Fig.10. The batch number clearly visible within the Straumann™ implant before firing.

Microscopic examination of the chambers revealed the batch number clearly visible within the Straumann™ implant before firing as shown in Fig. 10. Following the incineration the healing cap was removed easily. It can be seen in Fig. 11, the number was still visible, although not as clearly as in Fig. 10. Following the removal from the furnace of implants from the other companies and unscrewing of the fixtures, their internal chambers also showed little oxidation (Fig. 12). No batch numbers were observed in the other studied implants.

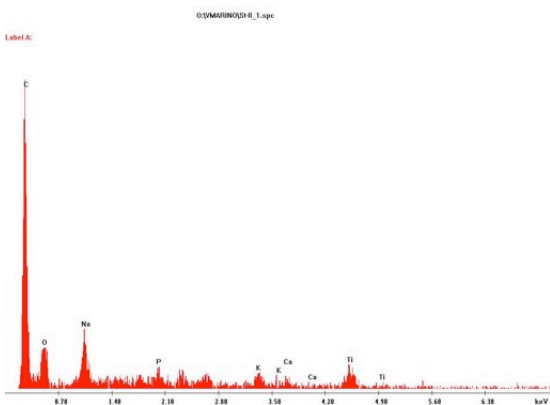
Fig.8. Elemental analysis of the black area depicting a peak of carbon.

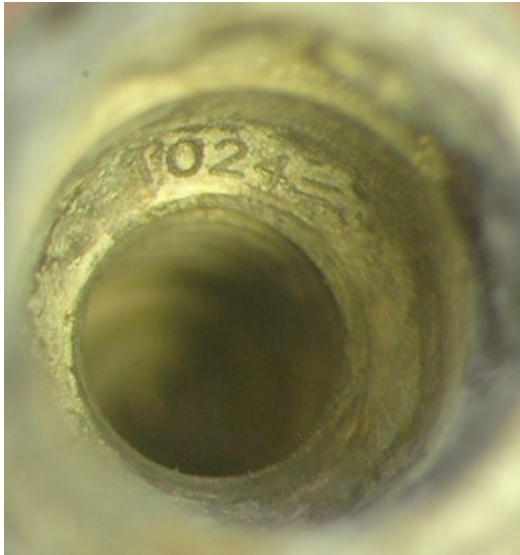
Fig.11. The batch number within the Straumann™ implant after firing.

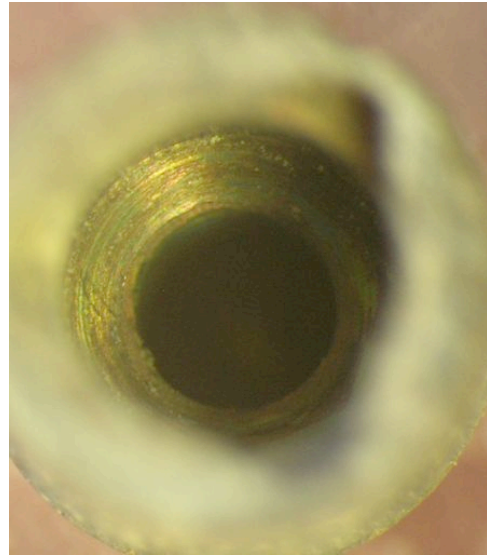
Fig.12. The internal chamber of the Nobel Biocare Replace Select™ 4.3 x 8mm after incineration.
